City Hall

WJE April 2021 Condition Assessment

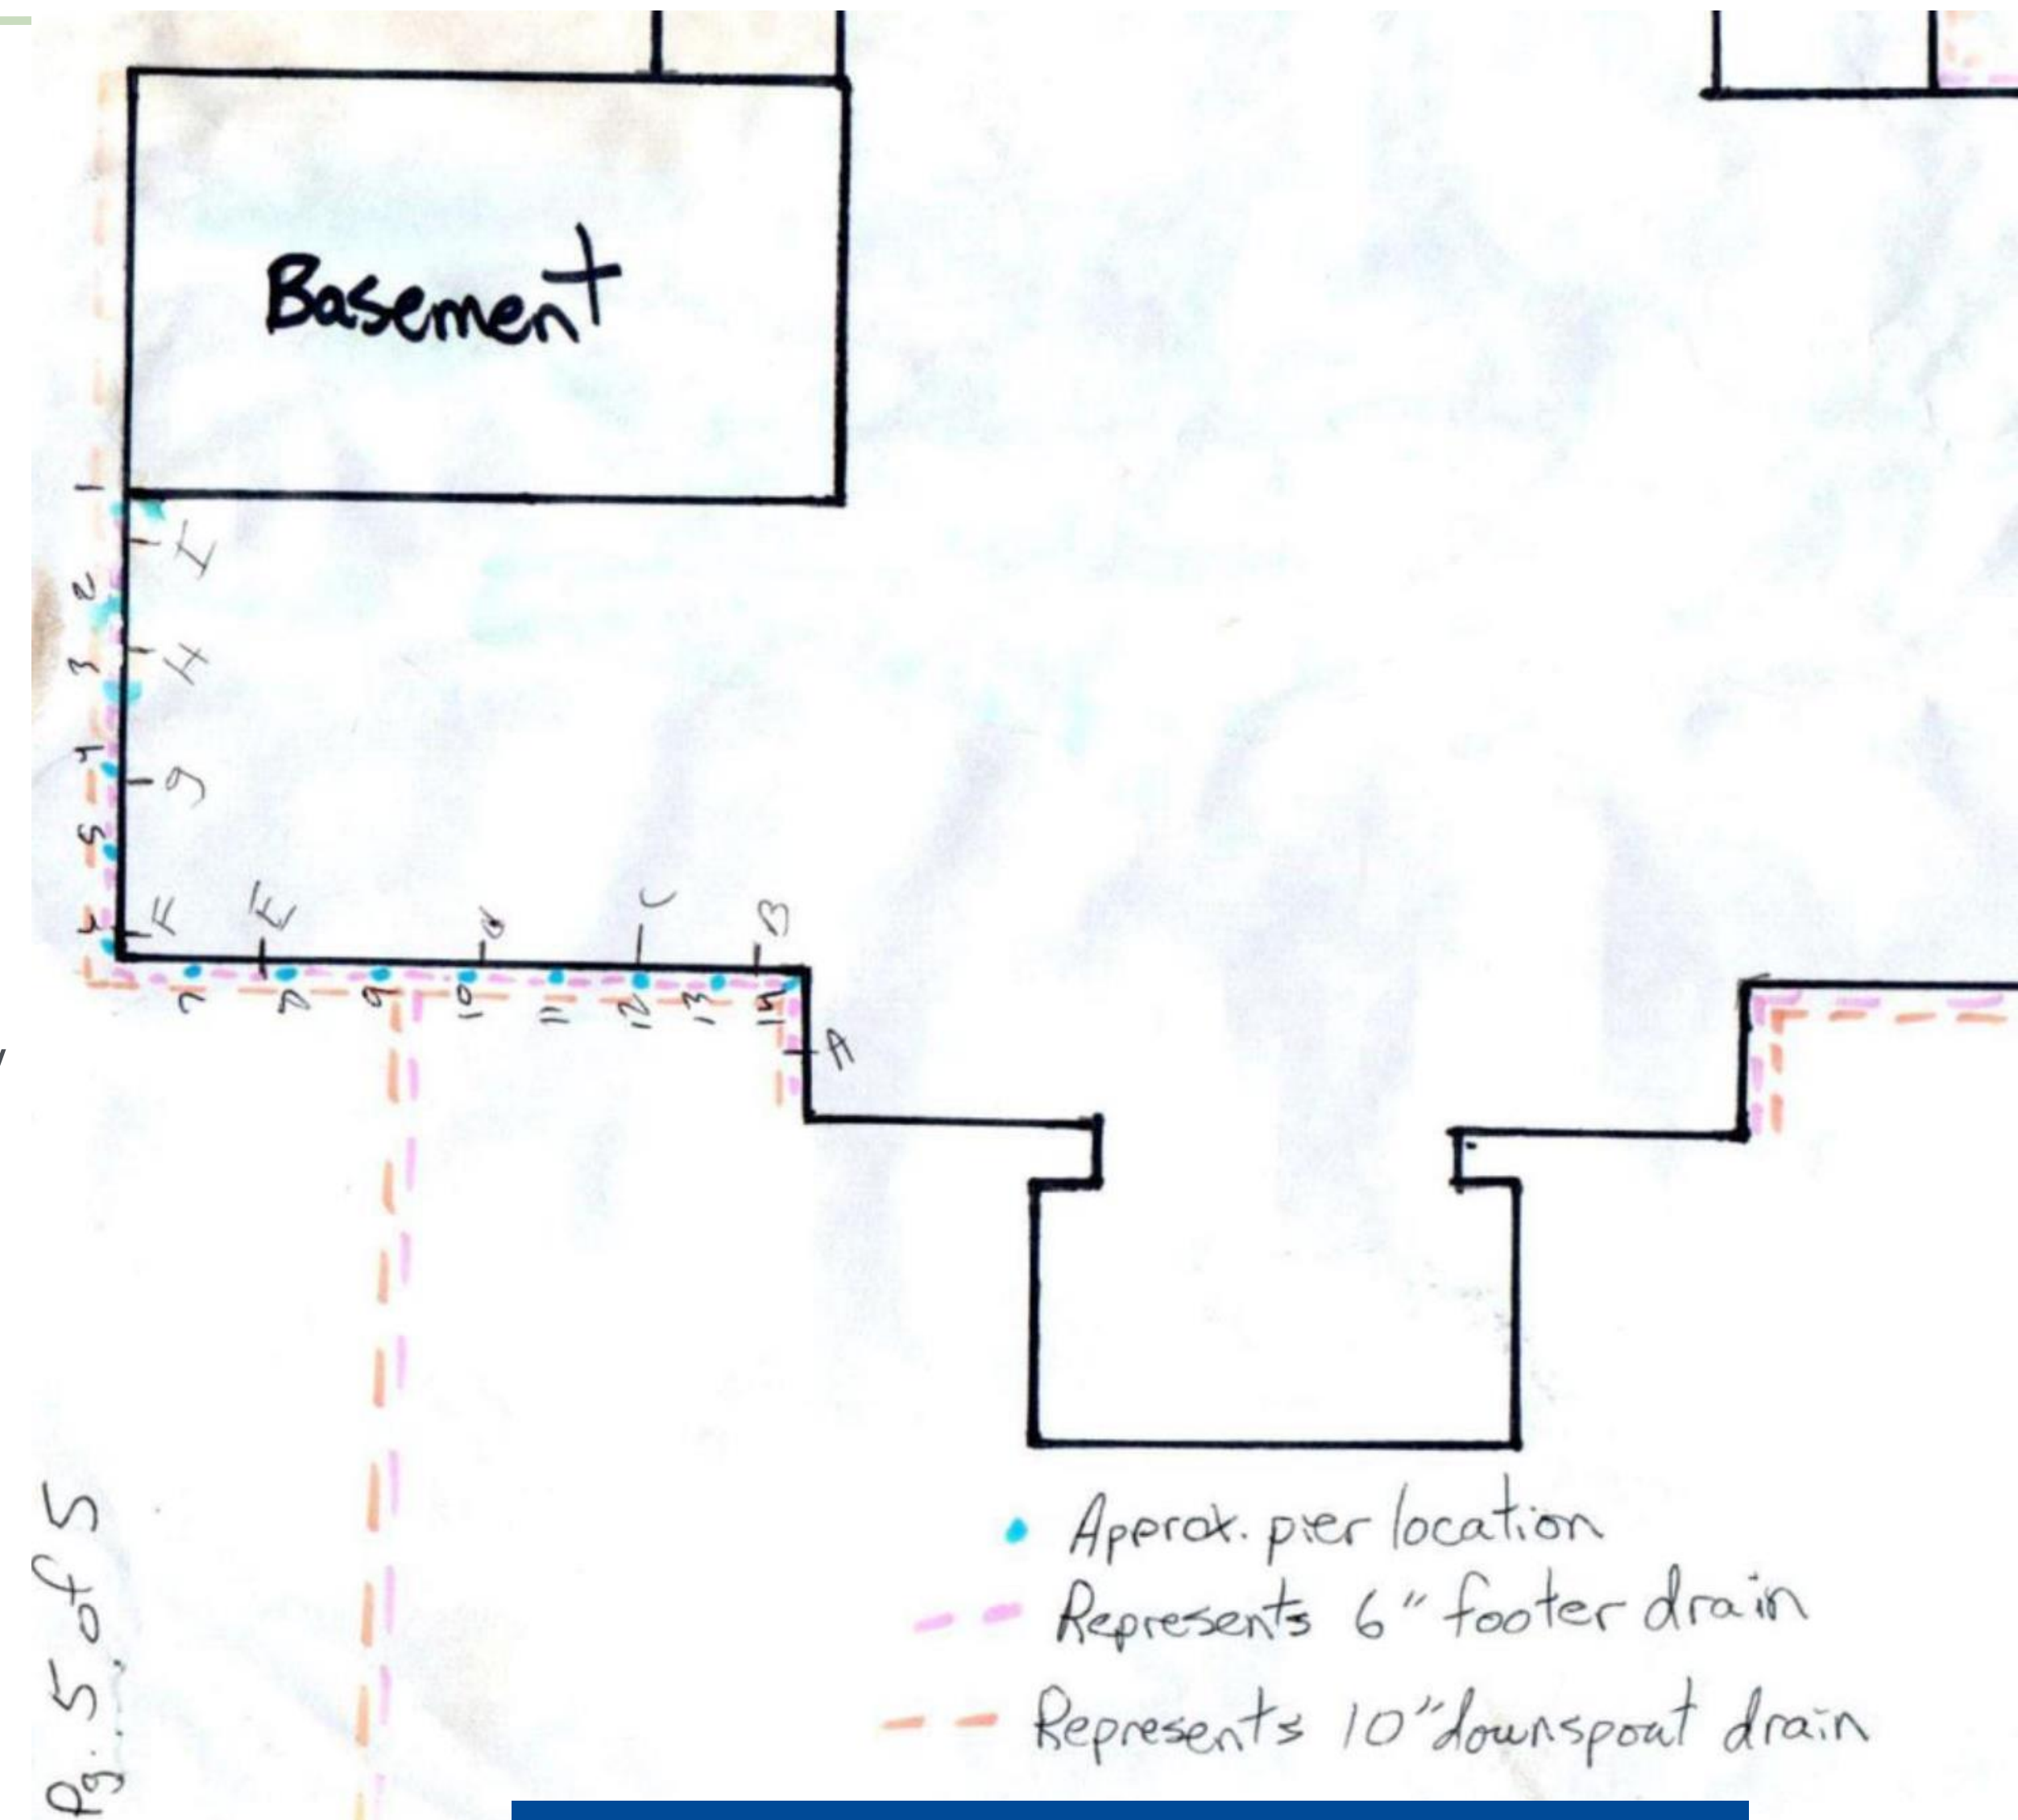
Excerpt from plan sketch showing helical pier installation locations installed in 2012

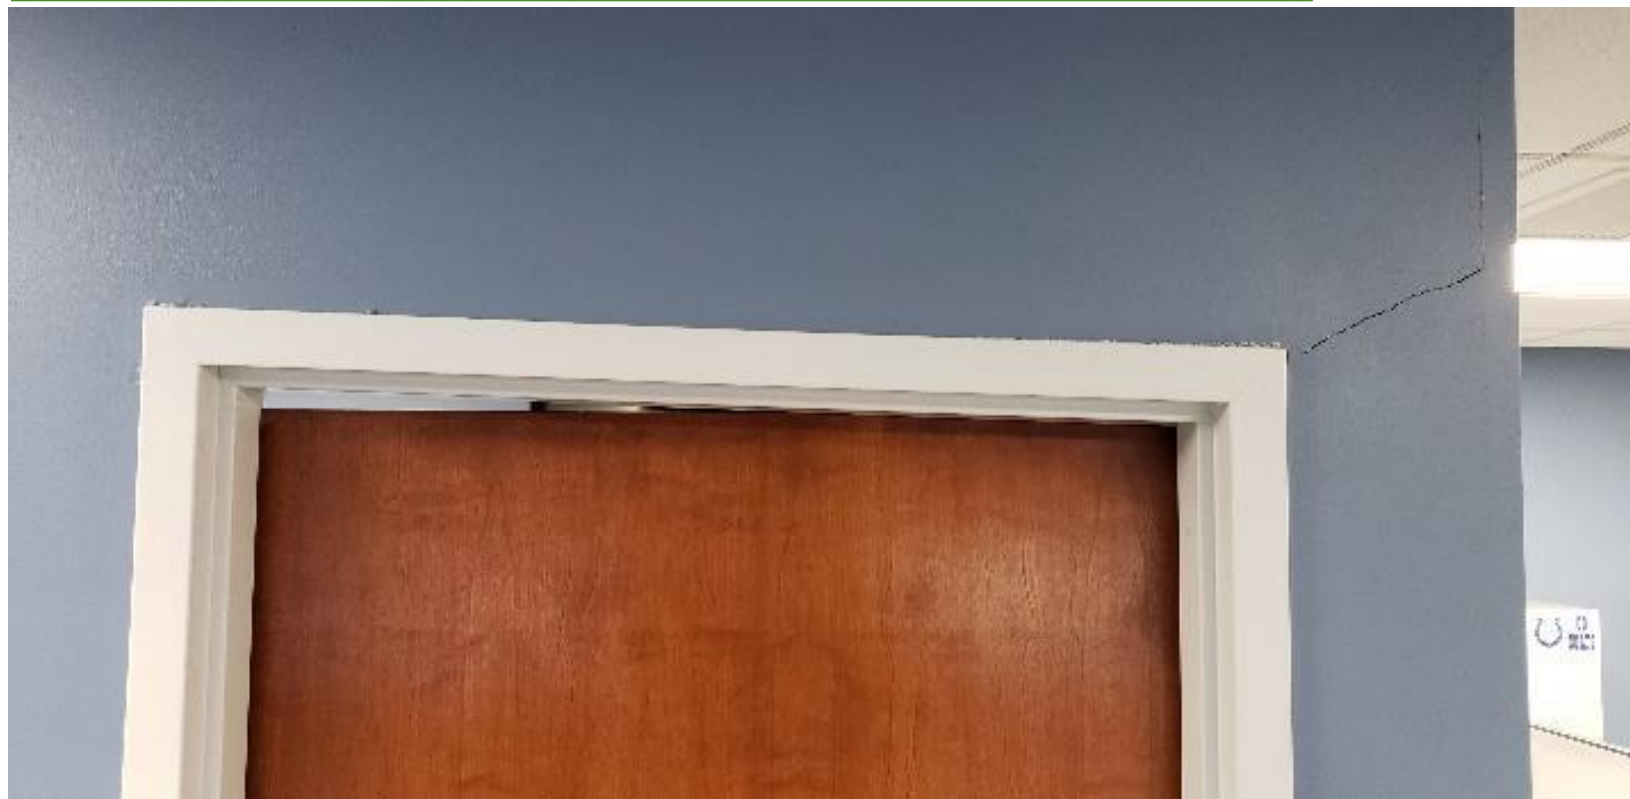
Crack in wall widened at increasing height

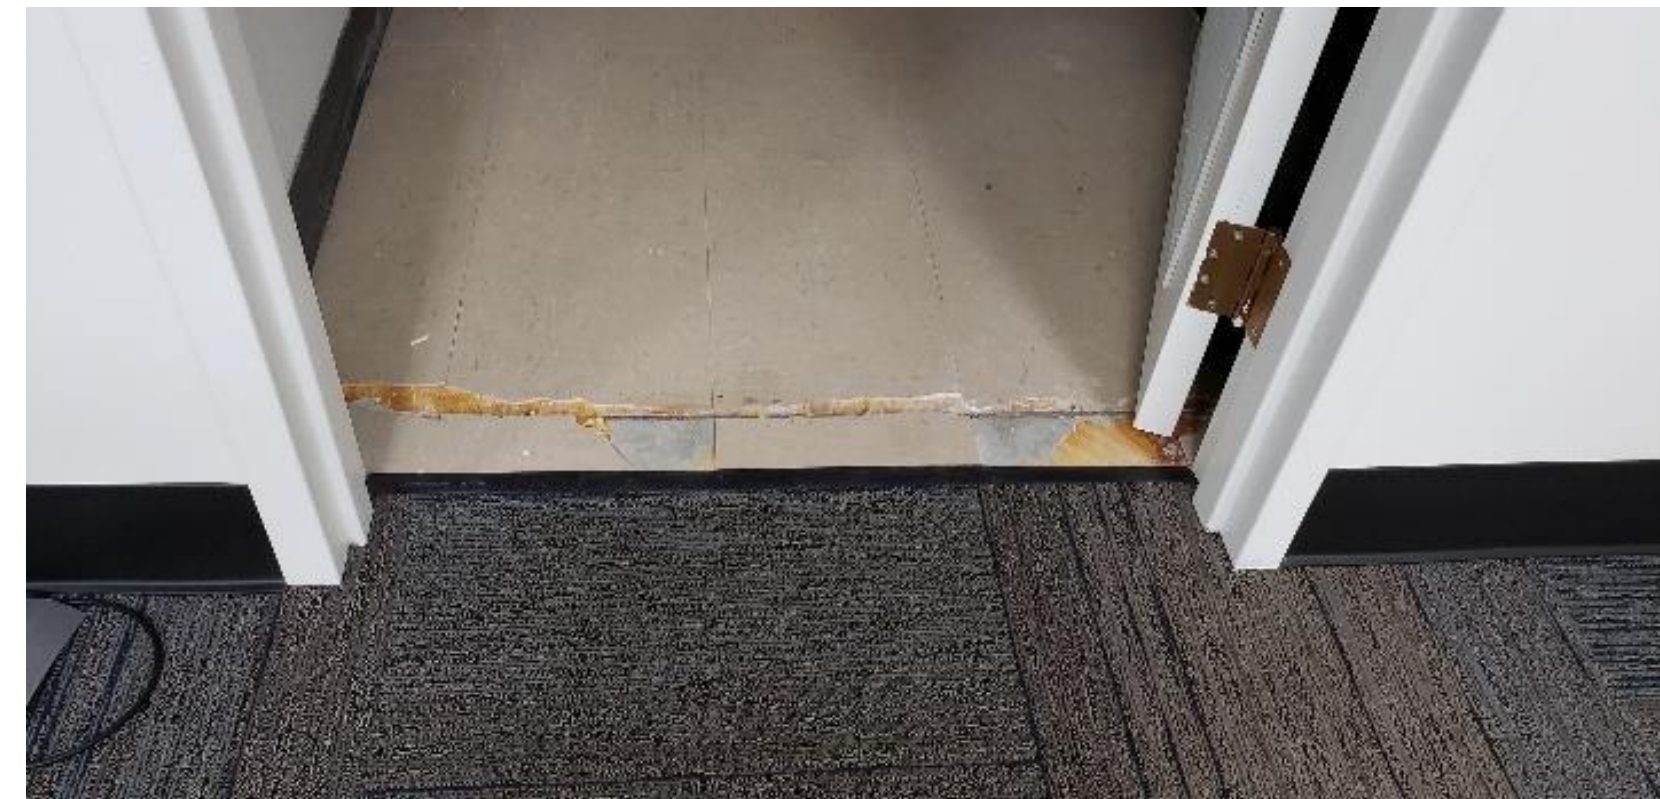
Cracked floor tiles at door threshold to the server room at the second floor

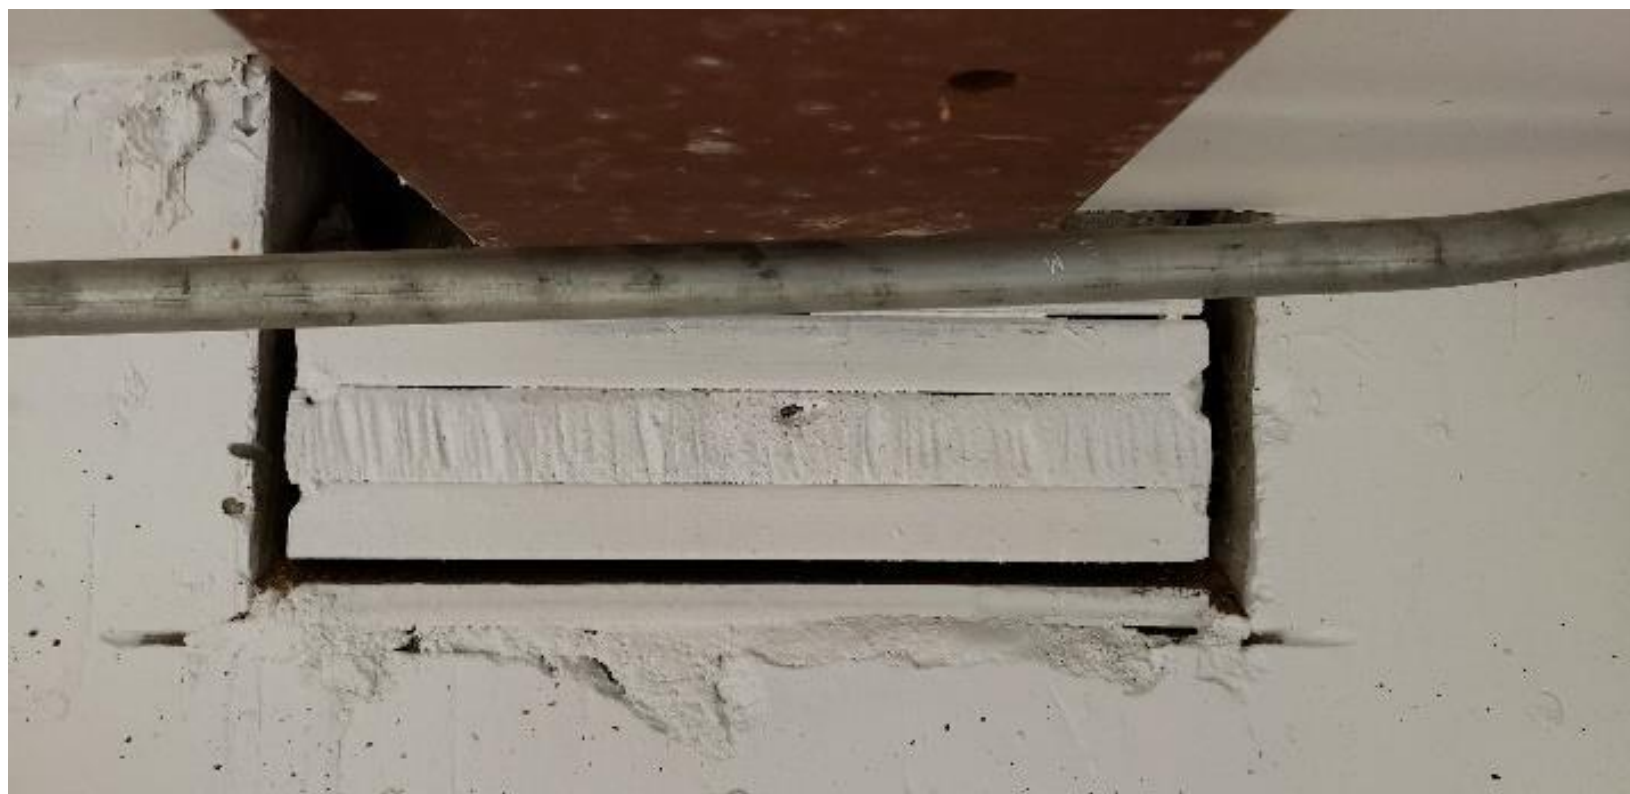
Steel wide-flange beam with gap between the bearing surface of the pocket

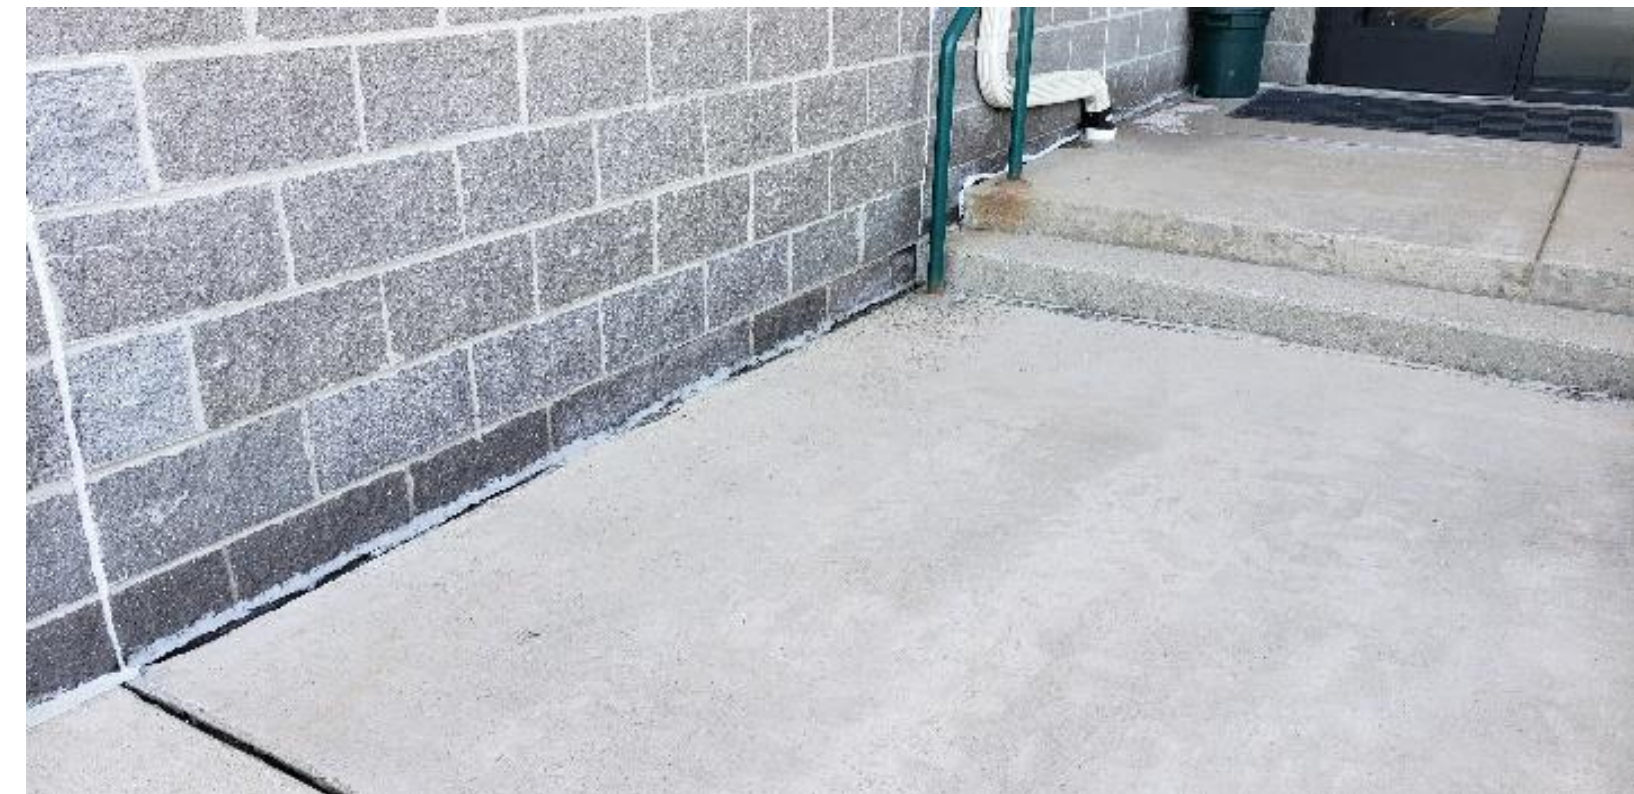
Approximately 1 inch of vertical displacement of the concrete flatwork at auditorium exterior wall

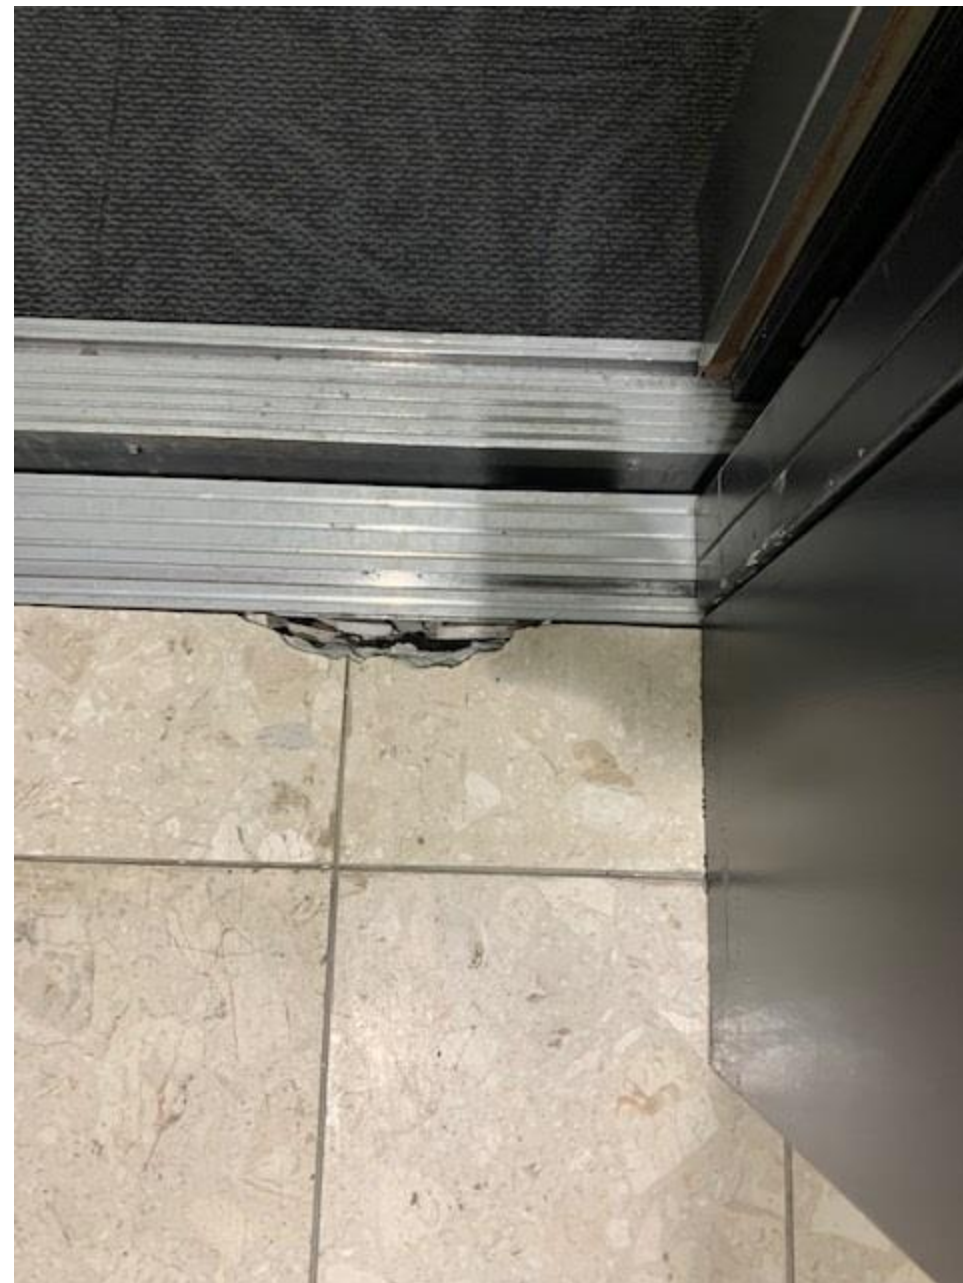
Second Floor Interior
West Side Elevator
Flooring breaking apart

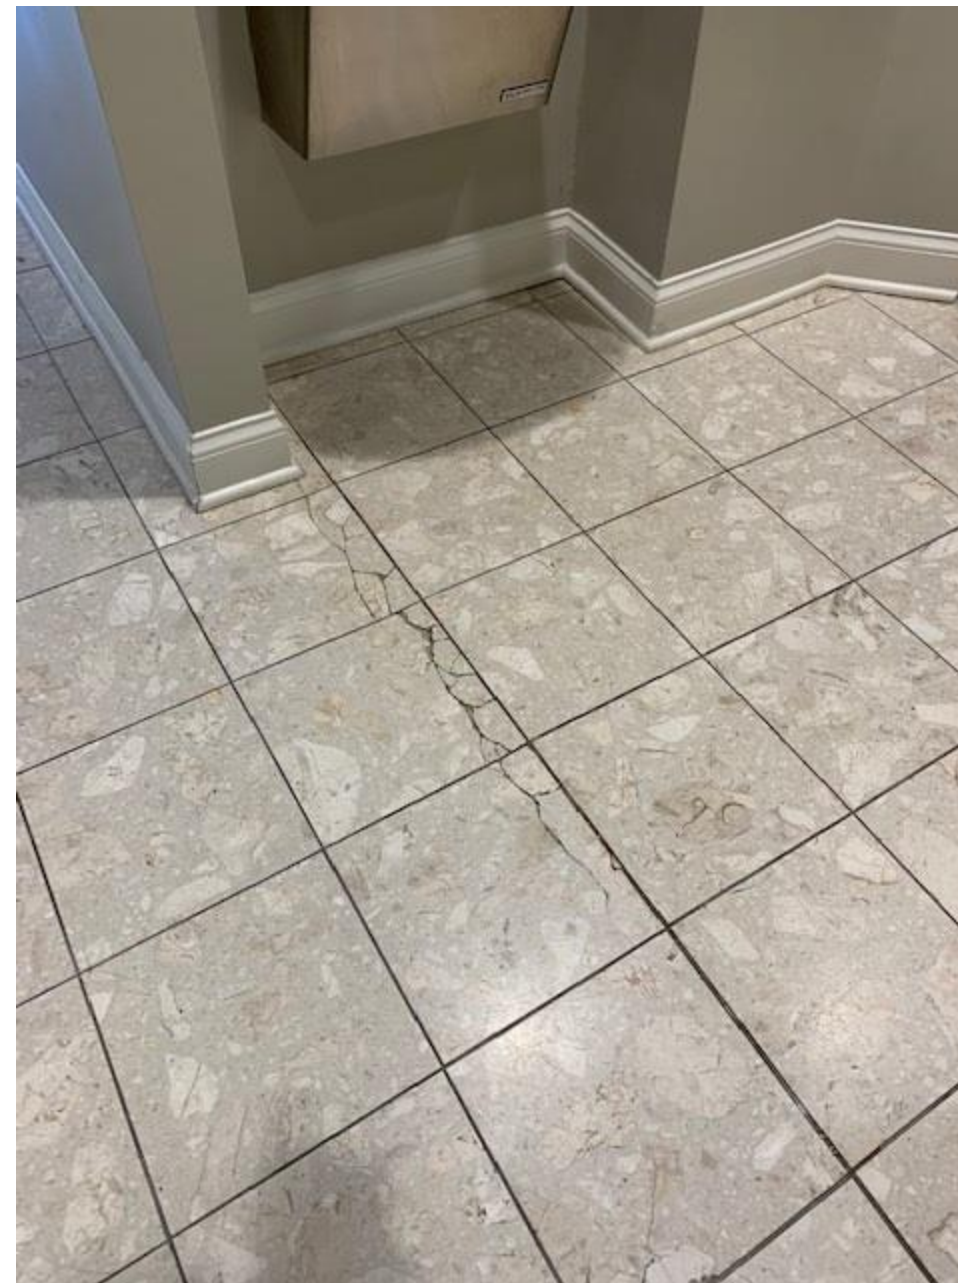
First Floor Interior
West Side water fountain
Flooring sagging significantly

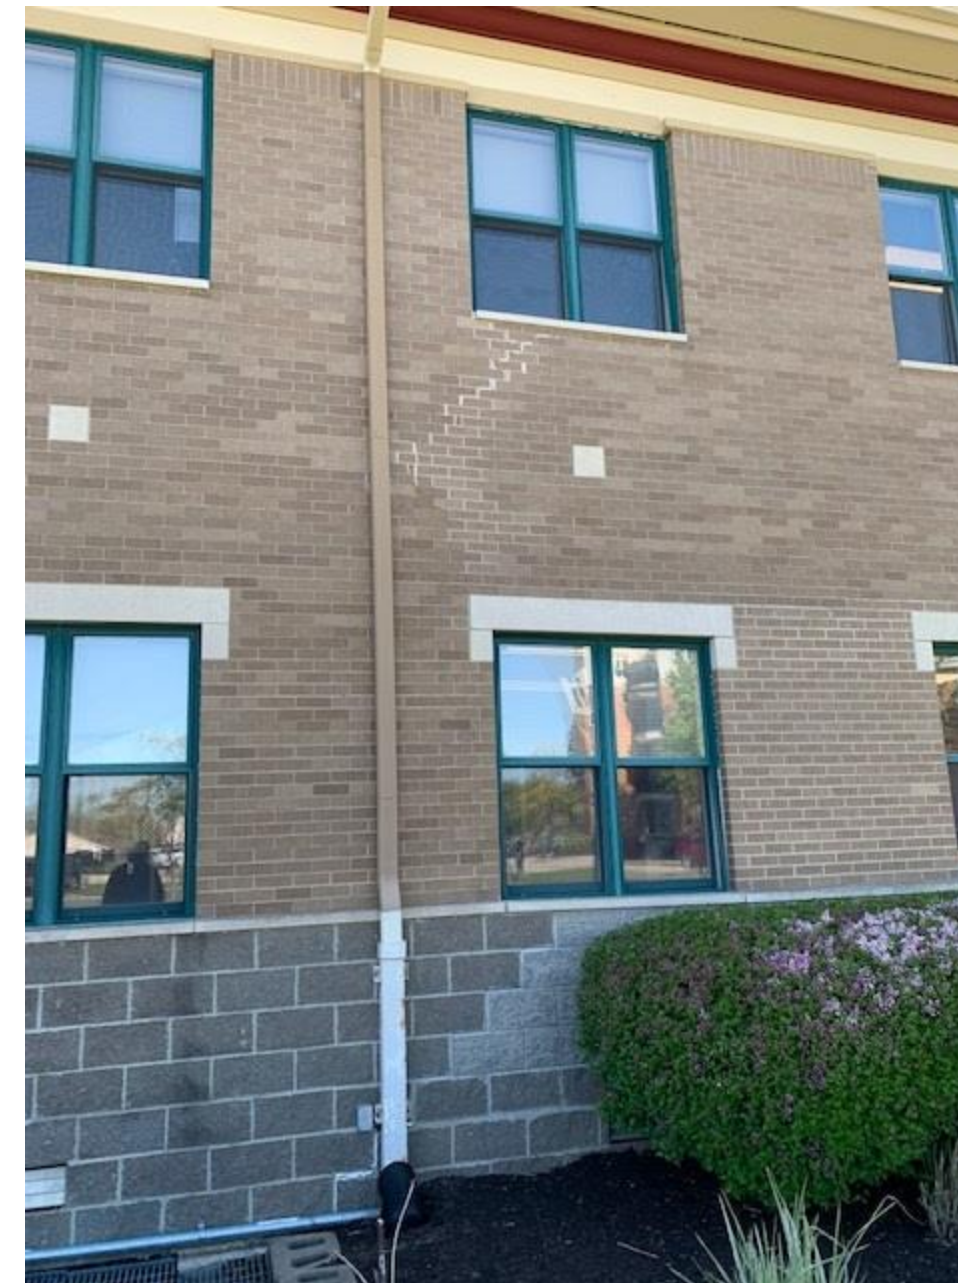
West Side Exterior
2013 updates beginning to
fail

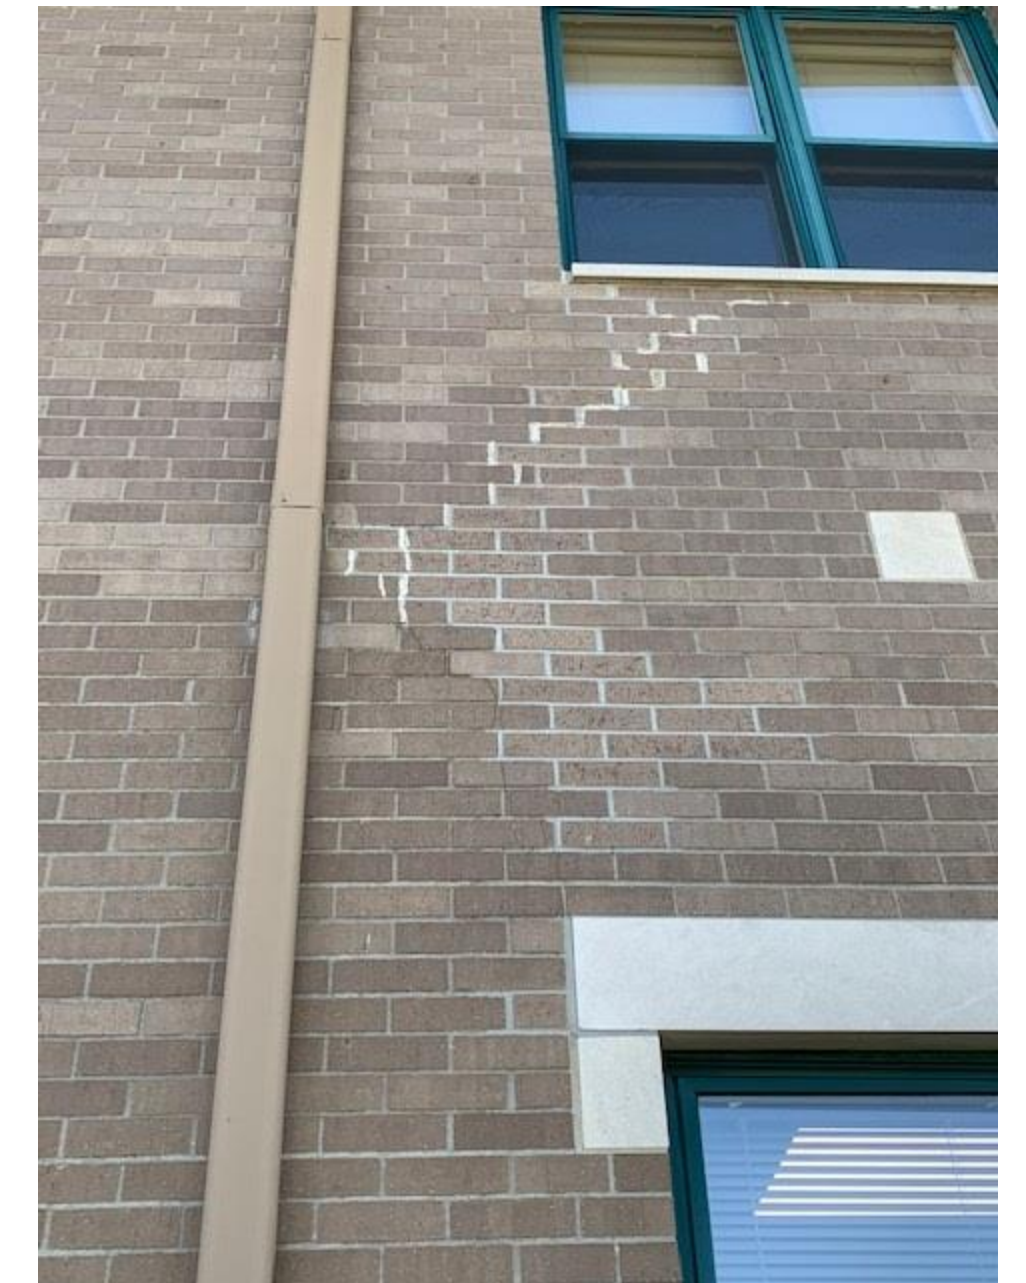
West Side Exterior
2013 updates beginning to
fail
