City of Fishers STORMWATER MASTER PLAN

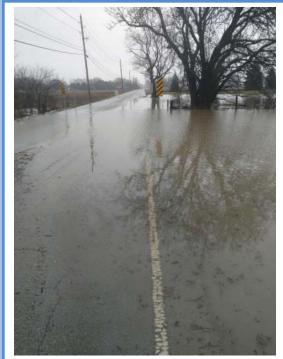
Figure 2-6 - 136th Street east of Limestone Springs

136th Street near the Limestone Springs subdivision is a primary example of the impact of these rain events. **Figure 2-6** shows the flooding

In the case of this area, the driving conditions were unsafe as portions of the roadway were impassable causing eastbound traffic to cross into the on-coming westbound traffic to avoid the flooded lane. This can create traffic safety issues in heavily traveled roadways. The standing water within the fields and rear yards of the residents can also create safety and/or health issues for the nearby residents. Standing water is a cause for concern due to mosquitos being able to breed quickly in large areas of standing water. Although, no residential homes were directly flooded during these storm events, larger storm events could cause closure of the entire road or flooding of homes due to the inadequate culvert pipes and downstream conveyance system.

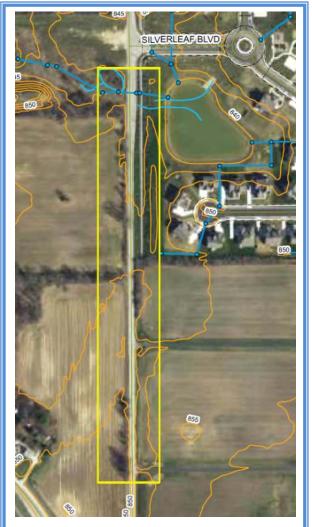
Figure 3-8 - Prairie Baptist South of Silverleaf Blvd.
Drainage Improvements

A field visit was completed on April 3, 2018 which confirmed pockets of standing water at the edge of the roadway. During the field visit it was also observed that vard flooding was occurring along the east side of Prairie Baptist further south. A large area of standing water was observed encroaching into the edge of the Upon reviewing available GIS roadway. mapping, it was noted that this area was in an unincorporated area outside the City of Fishers corporate limits. The division between the city limits and unincorporated area is along the south edge of the subdivision. Upon discussing with City of Fishers staff, the project area was expanded to include the area since the area could be annexed in the future.

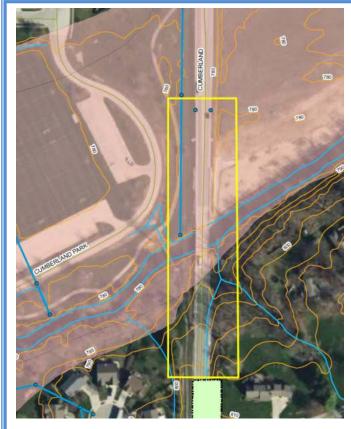
Figure 3-9 - Cumberland Road and 106th Street Bridge Replacement

The Cumberland Road Bridge is located just south of the 106th Street and Cumberland Road roundabout. This site is located east of the downtown area and is near the entrance to Cumberland Park. The bridge is identified as Hamilton County Bridge #164. **Figure 3-9** shows the bridge location with Mud Creek. This project is also located just north of the 10307 Cumberland Road Storm Sewer Upgrade project, which is described in greater detail in **Section 3.10**.

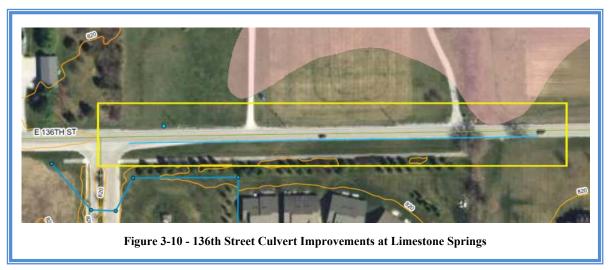
The 136th Street Culvert Improvements project at Limestone Springs is located within the north central portion of the City limits. The south side of 136th Street is located within the City of Fishers corporate limits and the north side of the 136th Street is part of the City of Noblesville corporate limits. The project site is located between Marilyn Road and Brooks School Road and just east of the Limestone Springs Subdivision. The project is the result of an insufficiently sized culvert pipe and deteriorating drainage facilities that cause yard flooding and frequent overtopping of the roadway. **Figure 3-10** shows the project area.

Currently runoff from the subdivision and field to the south of 136th Street flows north towards 136th Street where the runoff is conveyed under 136th Street via a small CMP culvert pipe. The culvert pipe drains into a field located north of 136th Street. No conveyance swales to carry flows were present as any swales were either overgrown with trees or silted in due to on-going farming of the adjacent land. The CMP pipe appears to be undersized and in deteriorating condition. Based

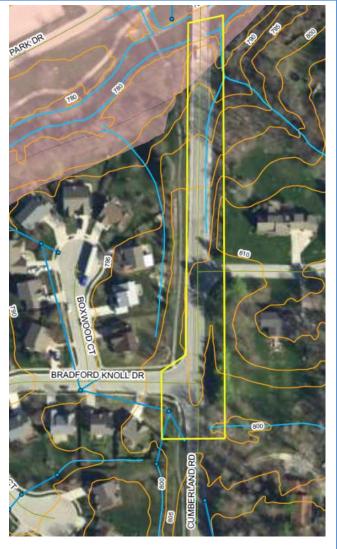
Figure 3-12 - 10307 Cumberland Road Storm Sewer Upgrade in Bradford Knoll

A small stream from the east flows through the parcel towards Cumberland Road. The stream enters a 36-inch pipe under Cumberland Road towards the Bradford Knoll Subdivision. On the west side of the Cumberland Road, the 36-inch culvert pipe enters the Bradford Knoll storm sewer system which consists of 24" pipes and various curb inlets. The Bradford Knoll storm sewer conveys runoff to a detention pond with an ultimate discharge to Mud Creek. Figure 3-12 shows the project area and estimated project limits (yellow The 10307 Cumberland Road polygon). parcel and culvert pipe is at the bottom end of the project limits. The blue line represents the incoming stream with the green lines depicting the 24" storm sewer system.

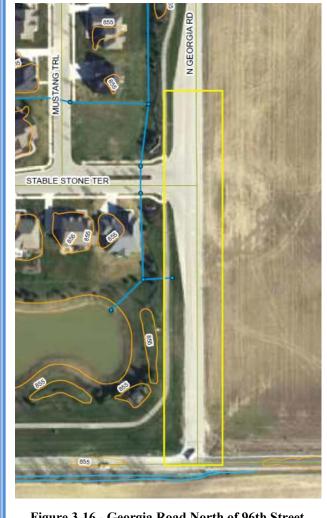
Figure 3-16 - Georgia Road North of 96th Street Drainage Improvements

The Georgia Road Drainage Improvements project is just north 96th Street on Georgia Road approximately 1.25 miles east of Olio Road. The project area can be found in Figure 3-16.

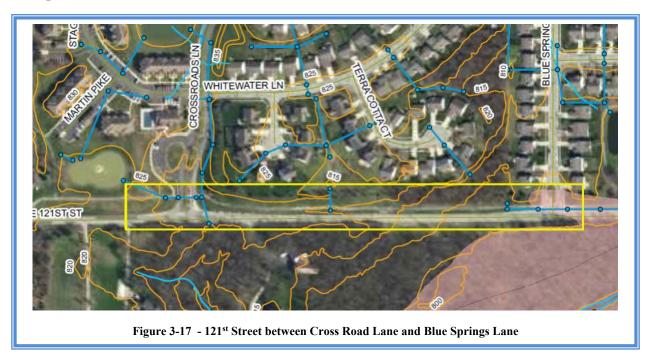
121st Street is a well-traveled collector roadway between Cumberland Road and Hoosier Road along the north side of the City of Fishers. The project is more specifically located between Crossroads Lane and Blue Spring Lane. This area includes mostly residential subdivisions with business development at the 121st Street and Cumberland Road. The project limits are indicated in **Figure 3-17**.

The project is the result of standing water along the edge of the roadway that does not drain to the roadside swales causing pavement deterioration along the north side of 121st Street. High water has been reported within the area during large rain events in the past.

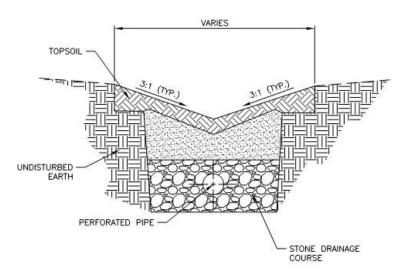
Figure 5-1 - Typical Hybrid Ditch Cross-Section

Because the City is within an MS4 district, certain water quality criteria must be met when constructing storm sewers. This criterion mainly deals with the reduction of sedimentation entering surface waters and control the rate at which runoff enters these surface waters. The hybrid ditch system meets all these criteria and is very successful at controlling the amount of volume that discharges from the system. In addition, the hybrid ditch is not completely dependent on the infiltration capabilities of the existing soils present at the site, so the proposed hybrid ditch system can be used in a variety of soil conditions and locations.

98th Street will have a separate inlet and pipe system that drains west to the pipe system that was previously installed. The roadside swales along 98th Street will be regraded to drain to the new inlets and the driveway culverts will be eliminated or replaced based on the grading patterns. **Figure 5-7**, shows the existing drainage system as well as the proposed improvements. The roadside swales would be constructed as a hybrid ditch system, per **Figure 5-1**, due to the flat topography within the area.

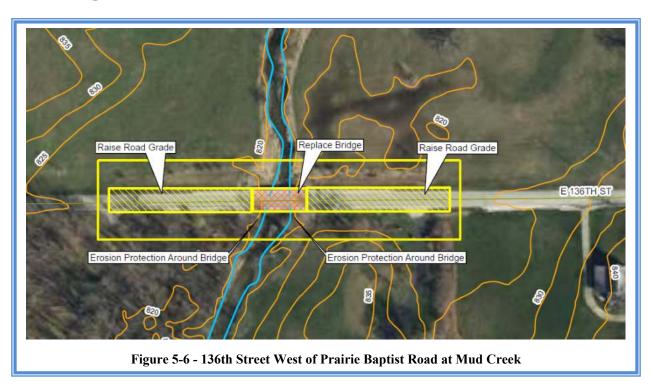
The project is located at Hamilton County Bridge #176 located just west of Prairie Baptist Road on 136th Street. The project is due to a portion of 136th Street east and west of the bridge being located within the 100-year floodplain and the City's goal to have all major roadways above the 100-yr base flood elevation (BFE). Per FEMA flood mapping and a review of the Hamilton County topography, the roadway elevations at the bridge as well as segments of the roadway to the east and west of the bridge are below the 100-yr BFE. The proposed project improvements are shown in **Figure 5-6** below.

The proposed project plan would be to replace the existing Hamilton County Bridge structure with a larger bridge opening and to raise the bridge high chord and roadway elevations above the BFE to mitigate any road overflows during the 100-yr storm event. A large single span bridge or three-span bridge structure would be required to convey flood waters through the bridge. One driveway east of the bridge could potentially be impacted by the road raising.

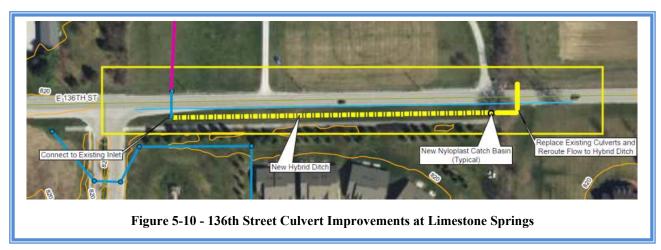
The project area is located on 136th Street between Marilyn Road and Brooks School Road. The project is the result of flooding at the eastern end of Limestone Springs Subdivision on the south side of 136th Street. The City of Fishers is located on the south side of 136th Street and the City of Noblesville is on the north side. Flooding within the subdivision is due to an undersized culvert under 136th Street and the lack of a defined drainage swale north of 136th Street between the culvert and the TJ Patterson Drain. The project area is shown in **Figure 5-10**.

During large rainfall events the northeast corner of the subdivision and northwest corner of the future I-Town Church property floods. Water also flows over 136th Street causing road closures

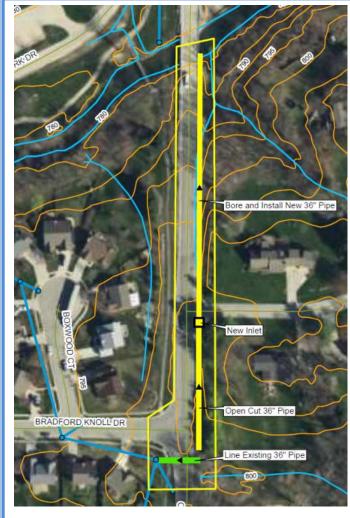
Figure 5-12 - 10307 Cumberland Road Storm Sewer Upgrade in Bradford Knoll

alternative would be to utilize the existing easement to construct a new diversion pipe and swale to Mud Creek. This alternative would also be feasible, however it would have major impacts on many of the residences. During field visits it was observed that the proposed rear yard swale would be installed within 10'-15' of some residential structures. The proximity of the swale to the residence would potentially cause other flooding concerns and impacts.

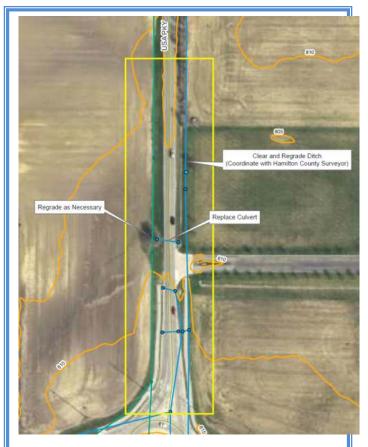
Figure 6-2 - Lantern Road and USA Parkway Drainage

The proposed maintenance activities would include replacing the existing CMP culver pipe under USA Parkway with a slightly larger RCP culvert pipe. The areas upstream and downstream of the pipe would be regraded to provide positive flow.

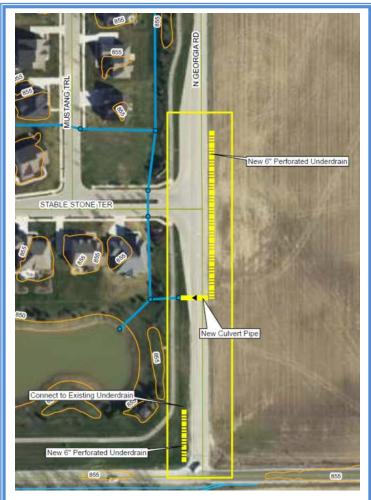
Figure 6-4 - Georgia Road North of 96th Street Drainage Improvements

As shown in **Figure 6-4**, the project would include the installation of an inlet and pipe system along the east edge of Georgia Road to collect the standing water. The pipe system would be connected to an existing inlet on the west side of Georgia Road south of the subdivision entrance. In addition, an underdrain would be installed/extended to the south along the west side of Georgia Road to alleviate standing water at the intersection.

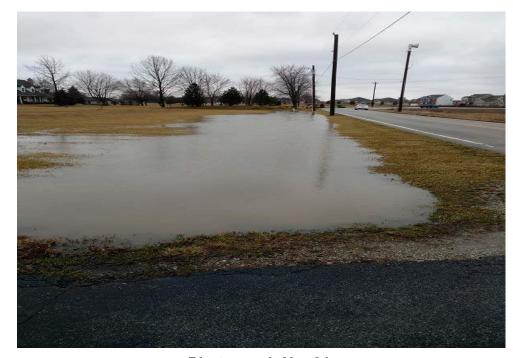
Photograph No. 21
Loking North along the West side of Prarie Baptist Rd just South of Silverleaf Blvd

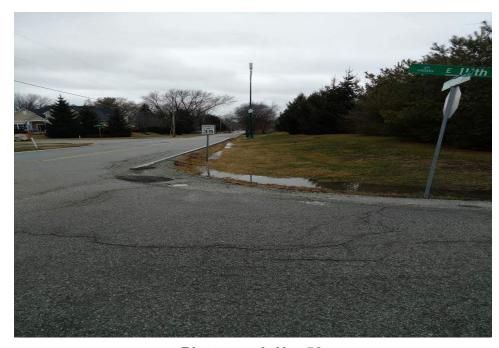
Photograph No. 53
Looking North along the East side Hoosier Rd at the intersection of 111th St
